Sittertobel renovation improves track forces

Schweizerische Südostbahn worked with industry partners including Getzner Werkstoffe to renovate its historic Sittertobel viaduct and install a more optimised track structure. The benefits of the changes have been quantified in series of tests assessing the rail deflection generated by passing trains.

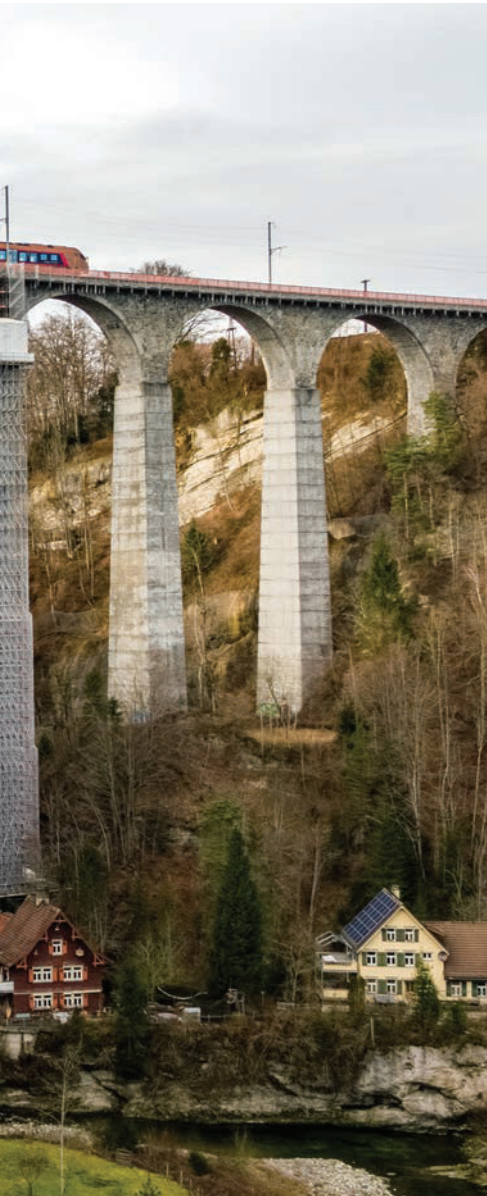
Fig 1. Track and superstructure configuration before and after the renovation work.

The problem areas were physically separated to alleviate the problems that had been caused by the combination of the transition zones and the rail expansion joint. The centre of the rail expansion joint was moved outwards to 14 m from the end of the fish belly. Elastic rail seats from Delkor were installed on the main span in order to adapt the stiffness of the open deck bridge track to that of the ballasted sections (Fig 1).

Based on calculations carried out using various product combinations, the configuration shown in Fig 1 was

determined to be the most appropriate. A stiffness value of 20 kN/mm was set for the rail seats on the open deck. A D1519 under-ballast mat with a bedding stiffness of 0.15 N/mm³ was laid under the ballasted track on the approach spans in the vicinity of the rail expansion joint, which was also supported on FFU sleepers. The turnout sleepers which support the connection to the standard track superstructure were equipped with elastoplastic SLB 2210 G under-sleeper pads. These are designed to preserve the track alignment and protect the ballast. Fig 3 shows the restored superstructure of the approach viaduct from the Herisau end.

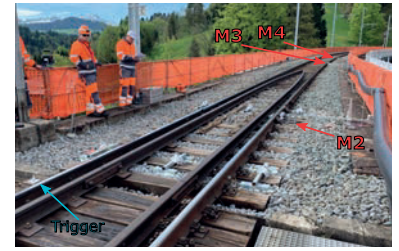
Fig 6. The deflection measurement calculation at points M1, M3 and M4.

Rail deflection at M1, M3 and M4 was measured using the approach shown in Fig 6. On the assumption that the tilting of the rail ϕ is low and any

movement in the y -direction negligible, a geometric relationship enables the deflection Δz at the middle of the rail base to be derived, and from that the deflection at the two rails (RF_{inner} and RF_{outer}).

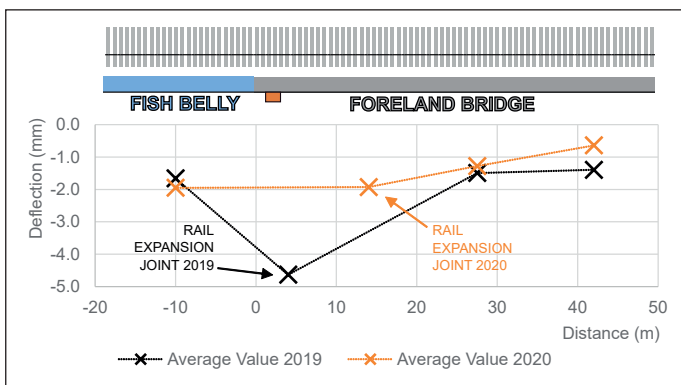
Below left: Fig 10. Average rail deflection before (2019) and after (2020) restoration.

After averaging out all the evaluated train passes, it is clear that the new superstructure design exhibits a much more homogeneous deflection curve (Fig 10). There has been a significant improvement to the transition zone, including the rail expansion joint.

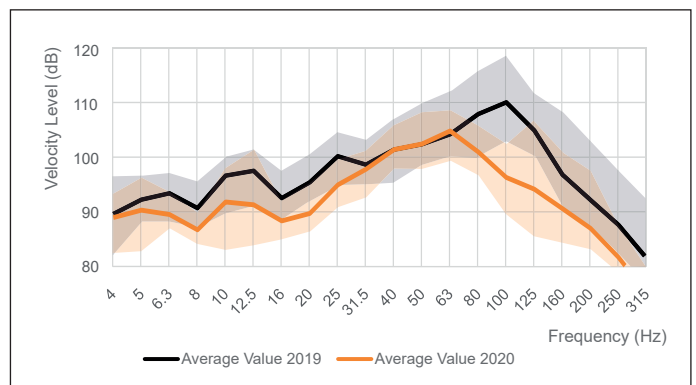
Below: Fig 11. Vibration measurement results at the transition between the fish belly and the approach viaduct.

The before/after comparison in Fig 11 shows the measured third-octave spectrum. The scatter band is defined by the minimum and maximum values

of all the passing trains evaluated. At first glance, it seems surprising that there was no visible improvement in the 31.5 Hz to 63 Hz range. The most probable reason for this is the choice of elastic components, which were dimensioned with a focus on optimising the transition. If one considers the natural frequencies of the fish belly with elastic rail fastening systems and those of the ballasted track with a rigid under-ballast mat, the result lies in the 30 Hz to 40 Hz range.

a whole shows a reduction in the vibrations transmitted into the viaduct of around 5 dB, with the levels of the estimated frequency bands deemed critical in terms of resonance staying the same. The vibration measurements support the results showing a more homogeneous transition as observed in the deflection measurements.
